#### MEMORANDUM

**DATE:** June 14, 2011

**SUBJECT:** Weekly Environmental Conditions for Systems Operations

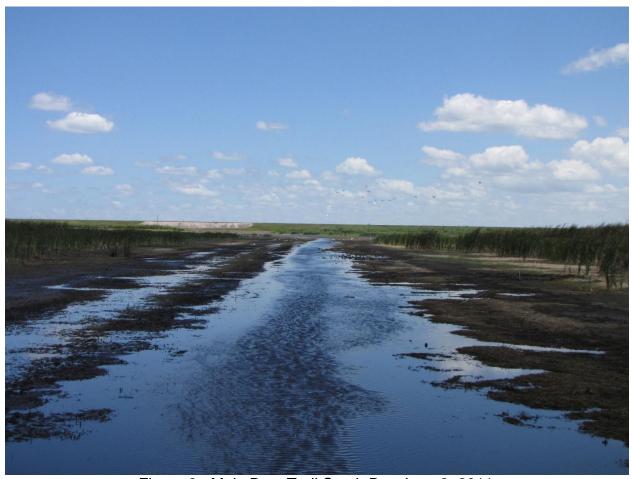
Figure 3: Main Boat Trail South Bay June 8, 2011

Lake stage continues to decline. The marsh is now entirely dry, and the large bays are beginning to dry out as well (Figure 3). Areas colonized by submerged aquatic vegetation (SAV) continue to shrink, although there may be some lakeward movement of plants as deeper areas become shallow enough to allow light to penetrate to the Lake bottom (Figure 4). The loss of marsh habitat puts additional stress on any remnant native apple snail populations and increases the probability that a multi-year recovery period will be necessary to restore apple snail populations to their pre-drought condition.

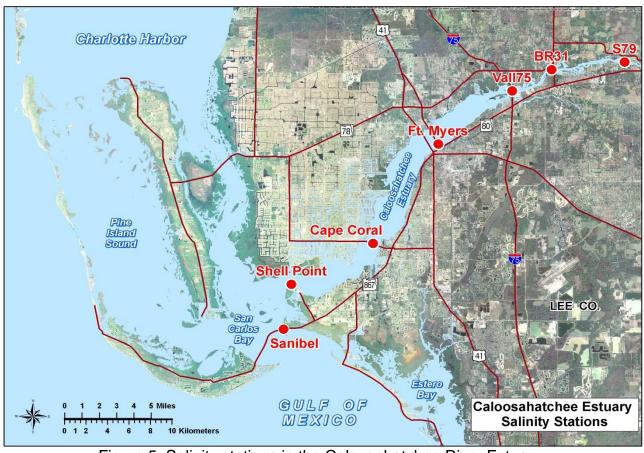
Figure 5. Salinity stations in the Caloosahatchee River Estuary.
